HORIZONTAL BARRIERS AGAINST RISING DAMP IN MASONRY

PATENTED SYSTEM

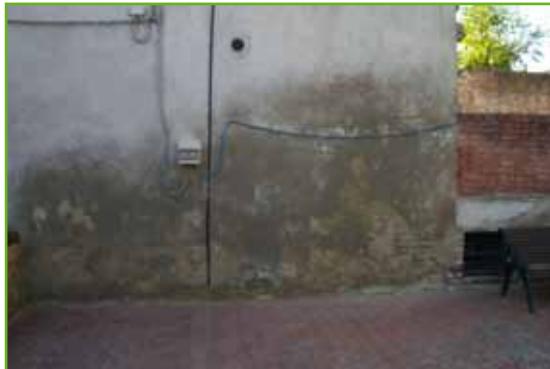
Change of colour, reduction of the thermal insulation.

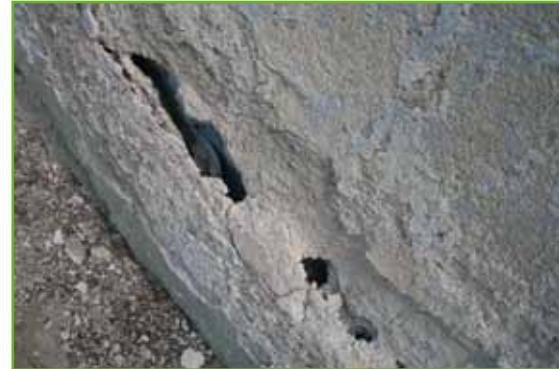
Damaged plaster / render

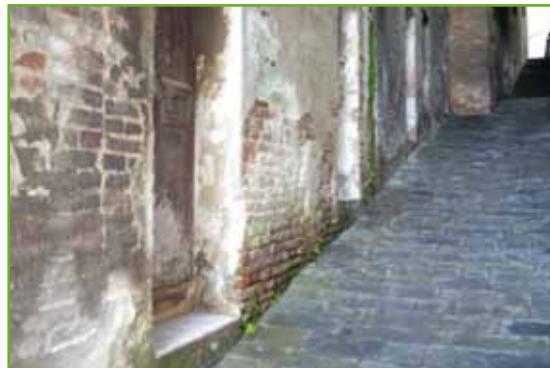
Destruction of render and mortar joints

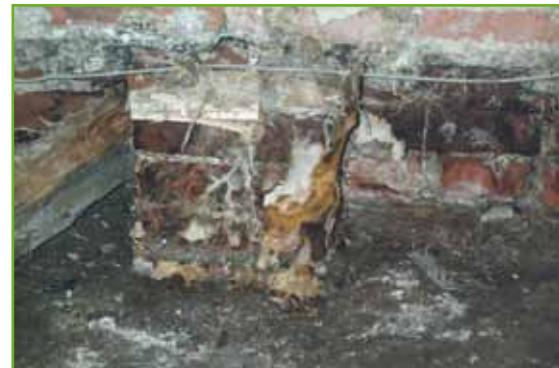
Development of mould and damage to the fabric of the structure

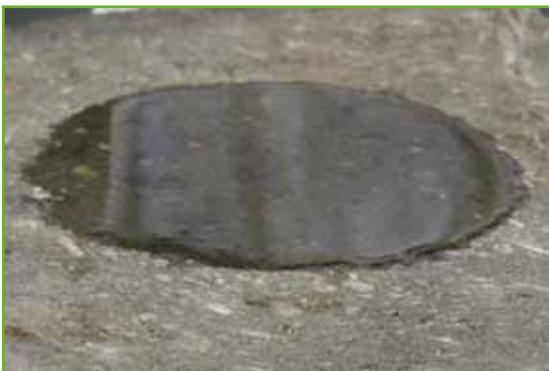
Interfacial tension of liquids (adhesion)

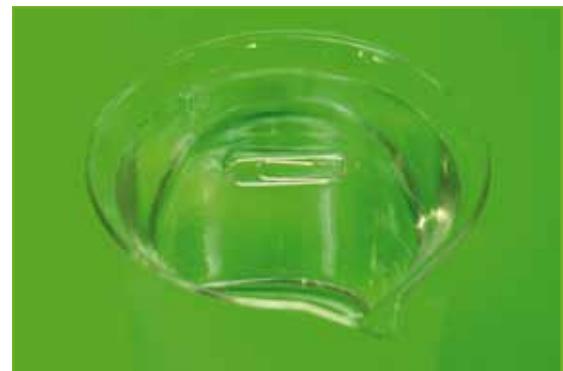
Surface tension of water (cohesion)

Rising damp is an effect created by the surface tension of a liquid (cohesion) and the interfacial tension (adhesion) between the liquid and the solid surface. Generally a liquid has the tendency to spread when it comes in contact with a surface. On the other hand liquids like water have a surface tension. These two forces together, lead to the effect that water rises in a narrow pipe (see graphic).

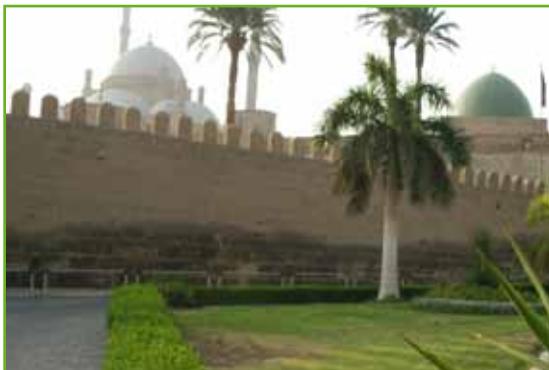
Example for rising damp

Building materials like bricks absorb water in a similar way to a sponge (see photo). This occurs because masonry as well as concrete contain small pores. Depending on the diameter of the pores, they can transport water upwards against gravity (rising damp). Pores with a radius between 10^{-7} m and 10^{-4} m show the most distinctive water transport and are referred to as capillaries. Between 20 % and 50 % of the pores in the building materials concrete, brick and mortar fall into that category. Pores with

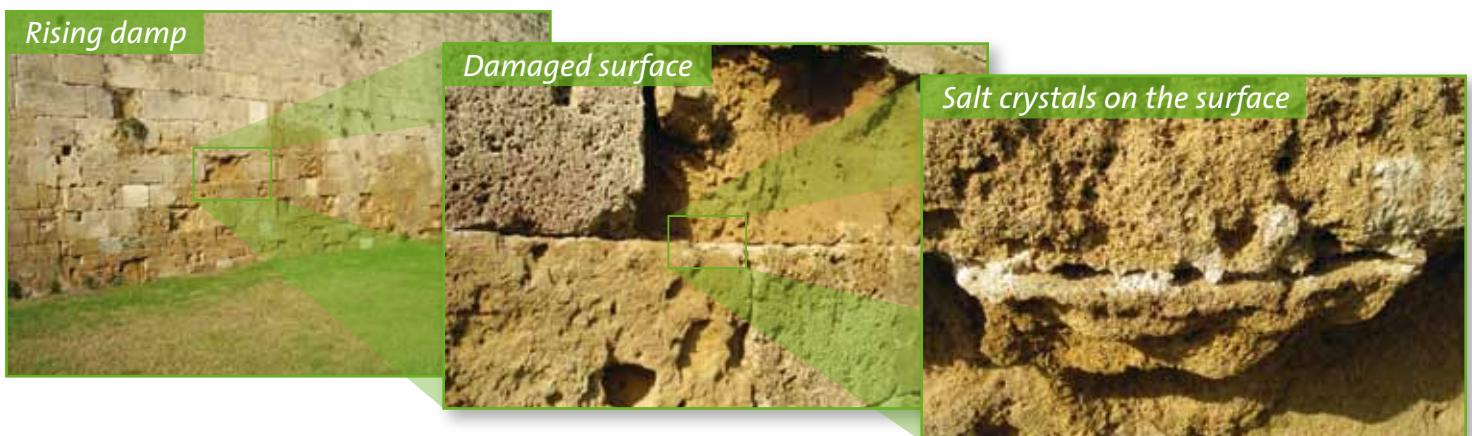
When the salt containing water evaporates in the surface area of the wall, the salt remains in the wall or on its surface, leading to an increase of the salt concentration. The salt crystallizes on the surface or in the pores of the building material. This process is characterized by directed growth, an increase in volume and high strength of the crystals. When salt crystals form in the pores of a building material over a longer period of time, a high crystallization pressure builds up. This eventually leads to a destruction of the pore. Once this process has proceeded far enough, the surface of the construction material becomes brittle and starts to fall off.

Destructive crystallization process

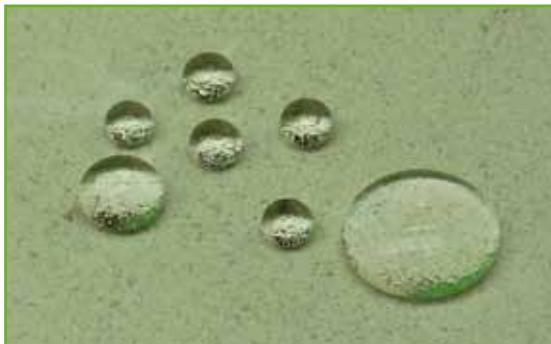
Hydrophobing : Making the building material water repellent

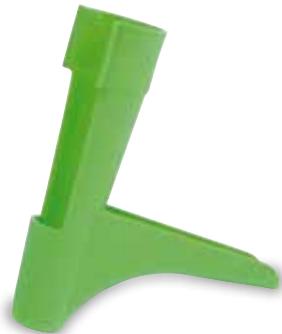
KÖSTER Suction Angle

The KÖSTER Capillary Rod acts like a wick, one end is inserted into the wall and the other end into the KÖSTER Suction Angle. From there, the

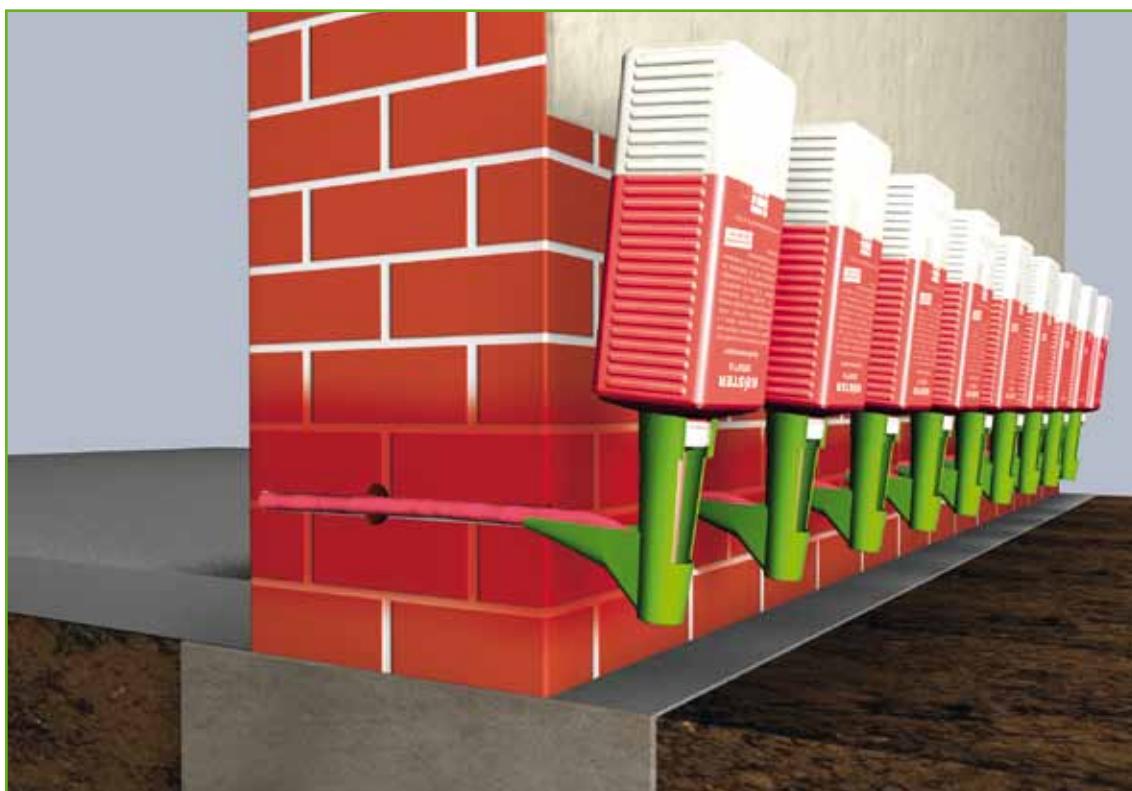
This is a crucial advantage not only when installing horizontal barriers into hollow bricks, vertically perforated bricks or old and cracked masonry, but also for all other conditions. The method allows easy control of the distribution

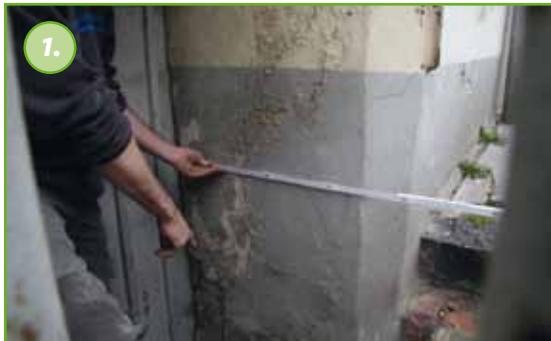
The masonry is from 1750, the existing plaster is damaged. The salt and moisture contents are high.

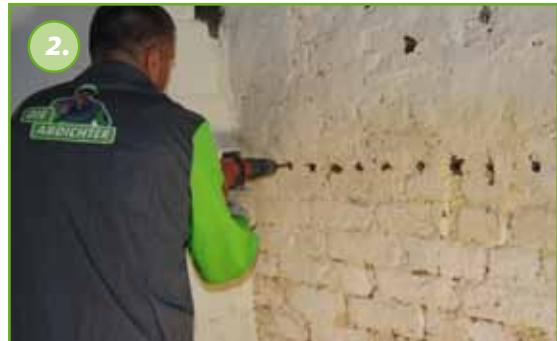
Boreholes are drilled into the interior walls at a distance of 10 cm from each other (wall thickness 45 cm) up to a depth of 40 cm.

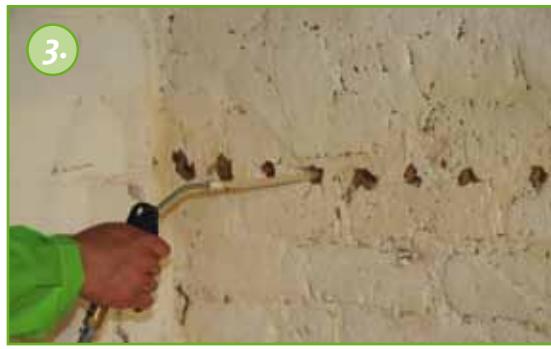
The boreholes are cleaned from dust by blowing the dust out of the borehole with pressurised air.

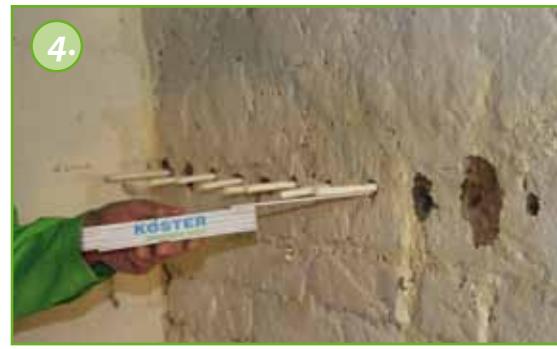
KÖSTER Capillary Rods are installed so that they protrude 7 cm from the borehole.

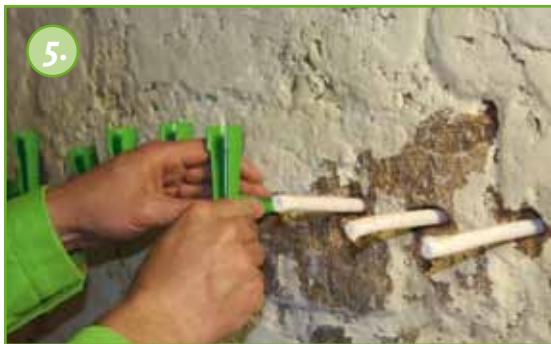
The KÖSTER Suction Angles are installed so that the KÖSTER Capillary Rods reach into the supply chamber of the KÖSTER Suction Angles.

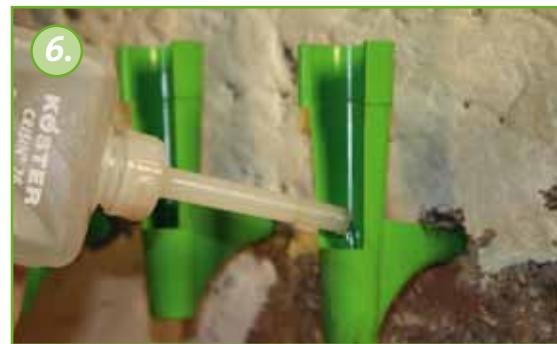
The supply chambers of the KÖSTER Suction Angles are filled with water in order to pre-water the KÖSTER Capillary Rods.

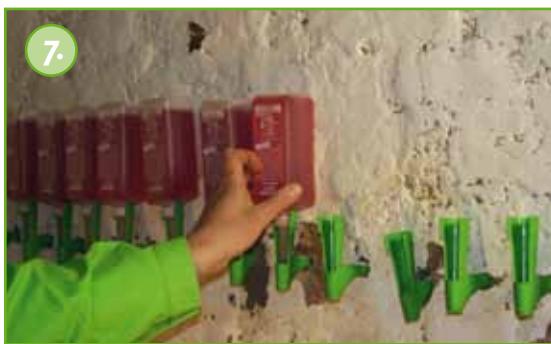
The KÖSTER Crisin® 76 cartridges are installed.

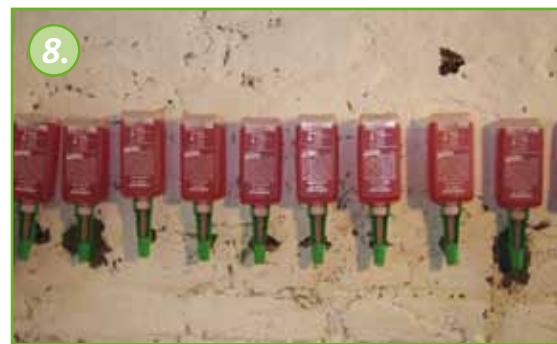
The pressureless injection of KÖSTER Crisin® 76 into the masonry starts immediately after the installation of the cartridges.

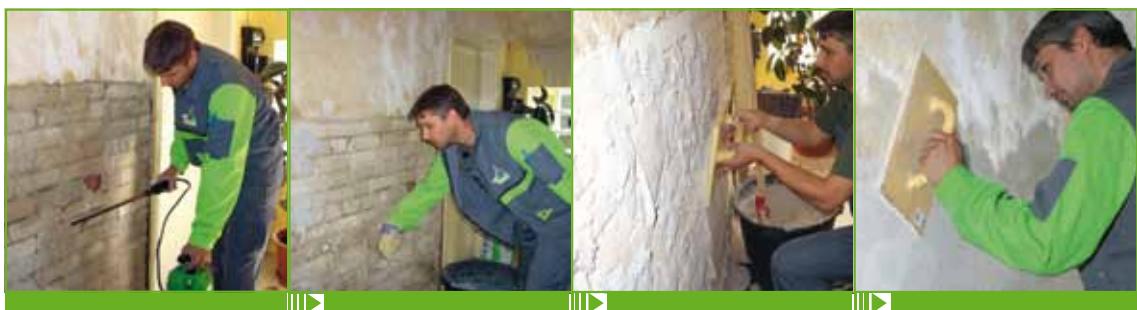
Remove old plaster. Fill breakouts and holes with KÖSTER Repair Mortar. Spray KÖSTER Polysil® TG 500 onto the surface to block salts and strengthen the substrate.

At the earliest after 30 minutes apply a plaster key to ensure optimal bonding of KÖSTER Restoration Plaster.

Apply KÖSTER Restoration Plaster onto the cured plaster key by trowel or use the KÖSTER Variojet.

After approximately 60 minutes, smooth the surface.

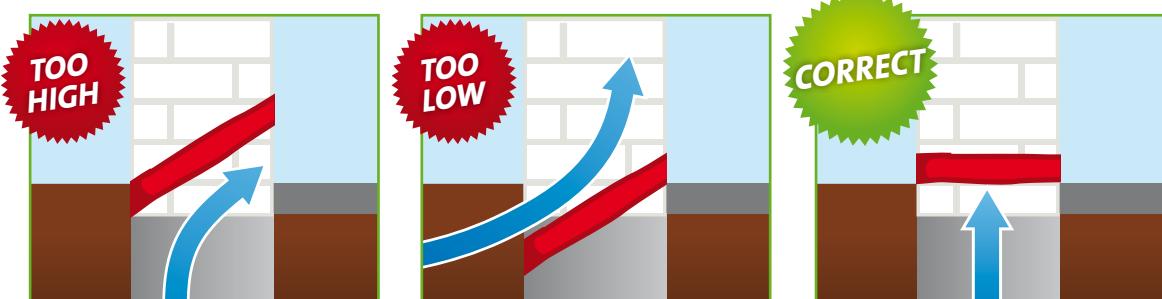
of diagonal drilling is that the installed barrier has different levels on the inside and on the outside. This is due to the angle of the boreholes and is illustrated in the following graphic. The practical result of this can be that moisture can still "overflow" or "underflow" the installed barrier.

The horizontally positioned system in contrast has the same height level on both sides of the wall and can thus be easily positioned correctly.

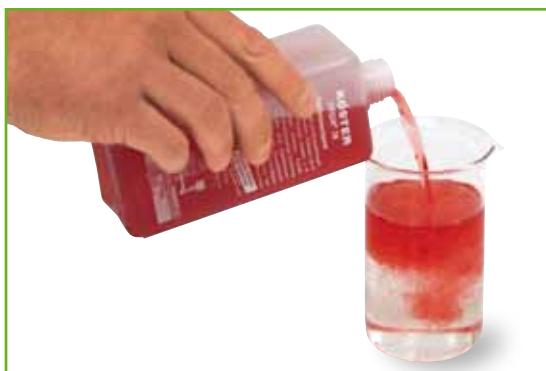
KÖSTER Crisin® 76 cannot be diluted with water

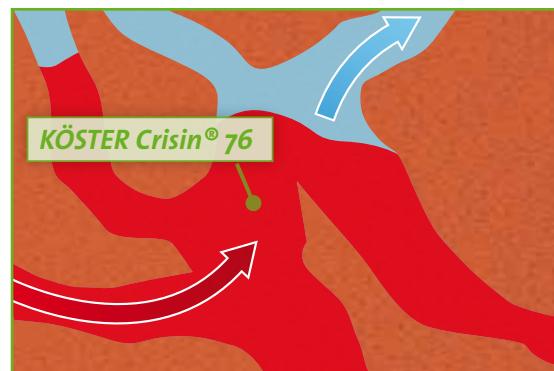
KÖSTER Crisin® 76 penetrates into the capillaries and pushes out the fluids.
